# Inspection Report

2053 Sample Road, Sterling Heights, MI 12345

**Inspection Date** October 8, 2019  
**Client** John & Jane Doe  
**Inspector** Scott Briggs

**Briggs Home Inspections, LLC**

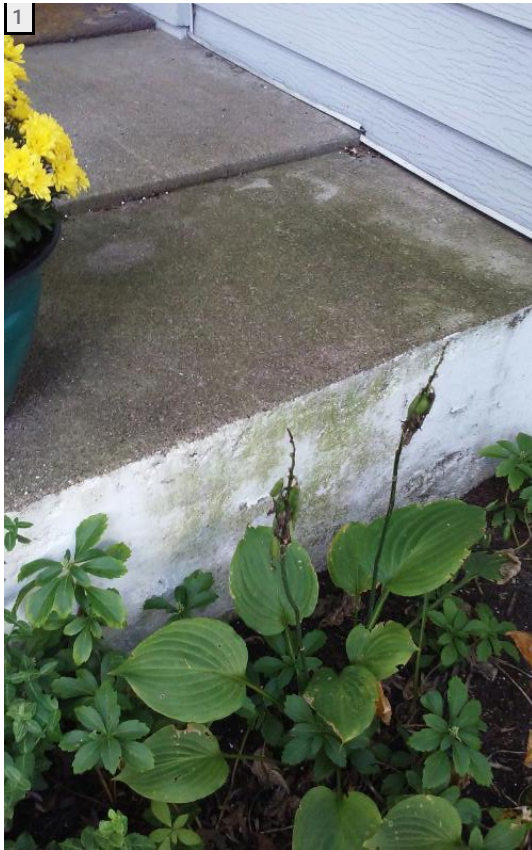
Observation to Monitor	
Slight moss possibly from the gutter	
Location	Exterior: Ground View

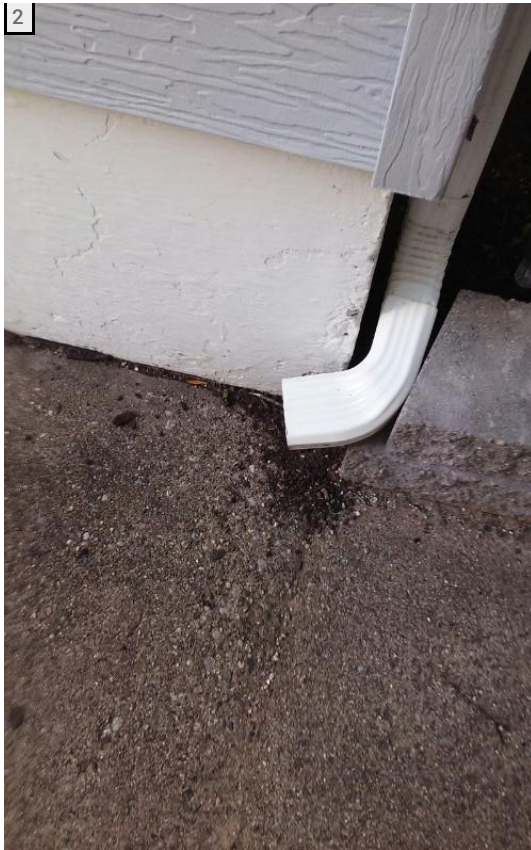
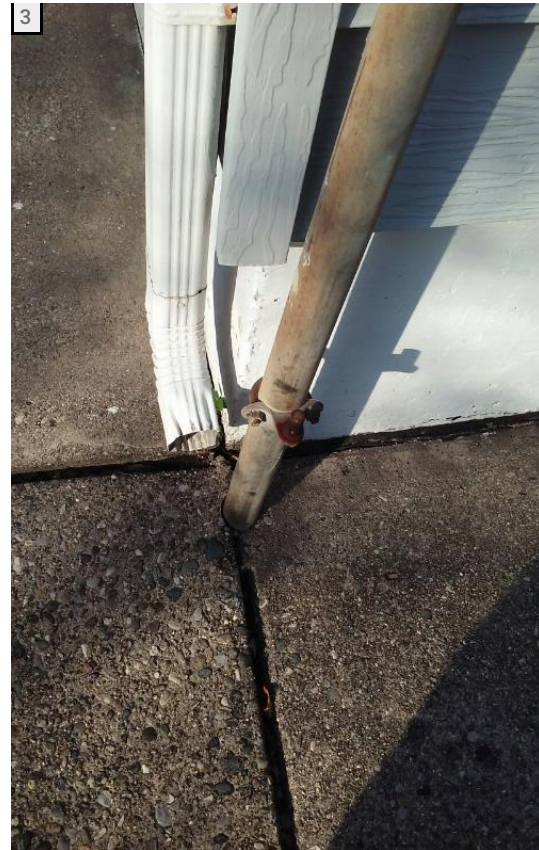
Moderate Concern	
Extensions are missing	
Location	Exterior: Ground View
Impact	Water flow is not contained and may drain near foundation increasing the risk of flooding
Suggested Action	Install downspout extensions reaching 5-6 feet from the building

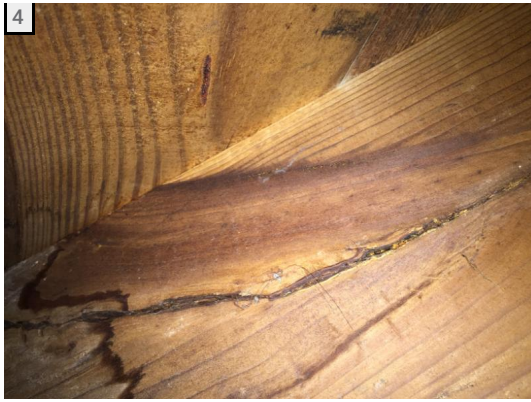
5) There is minor damage to a joist in the basement which has a closet above it on the floor above. Typically, closets do not hold a lot of weight. Whether you repair this or not, this house will still stand for at least another 50 years. For a house built in 1946, this is small for structural repair needs. This may be a bit mean, but I would recommend having a foundation company come out for a free quote and free advise. As a homeowner, they will all provide free quotes and advise. I want you to do this just to double check how I would fix it. If it was me, I would either sister it up with another board of similar dimensions as that small wood joist rests on a very large metal support beam. The metal beam is what is holding your house up. The wood joist is designed to transfer the weight onto that metal beam. Since that wood joist is cracked/ damaged towards its corner. I would go as far out with a sister joist as far as I could (but no further than the end of the joist being repaired that is resting on the metal support beam) and then take fairly large galvanized deck screws ( at least an inch and a half but maybe up to 2 inches and a half) and screw a couple dozen screws spaced out to attach the sister board to the damaged joist. You will need to use appropriately sized drill bits to drill pilot holes before the screws as you do not want to split the wood. It also may be possible to use a metal support bracket and accomplish the same. I do not anticipate this repair to be hard or complicated. However, if you are going to do it yourself, do it with your Dad with you, and I do recommend that you do it after you have a foundation company come out and obtain their repair advise. Have your Dad with you to hear how the foundation company would repair this. If its the same thoughts and simple the way I put it, then you can feel comfortable with the repair. If they say otherwise that it is some major repair and the house is going to fall down, I will refund your inspection. Though, I expect it will be simple as I described.

#### Joist damage

Location    Basement

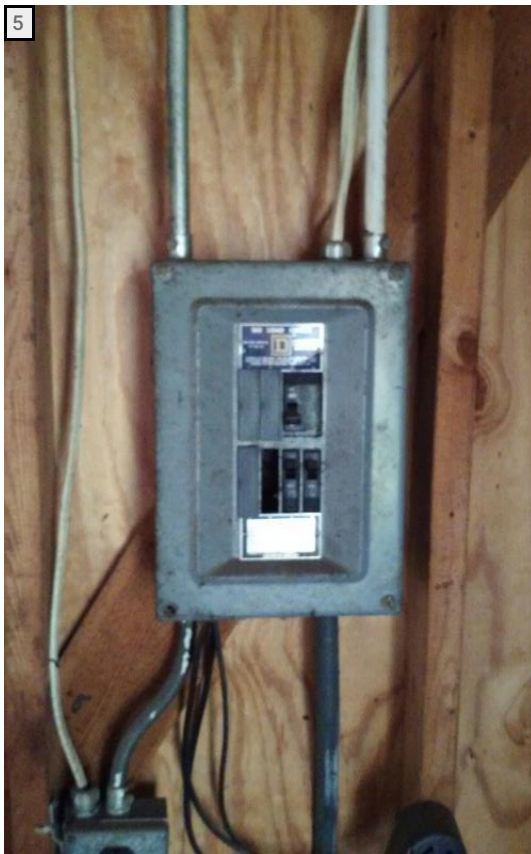
### Missing breaker

<b>Location</b>	Deattached Garage
-----------------	-------------------

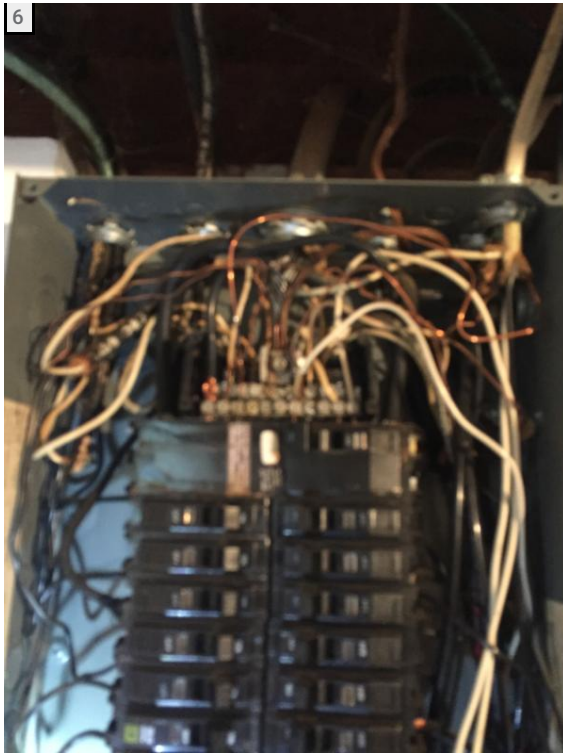
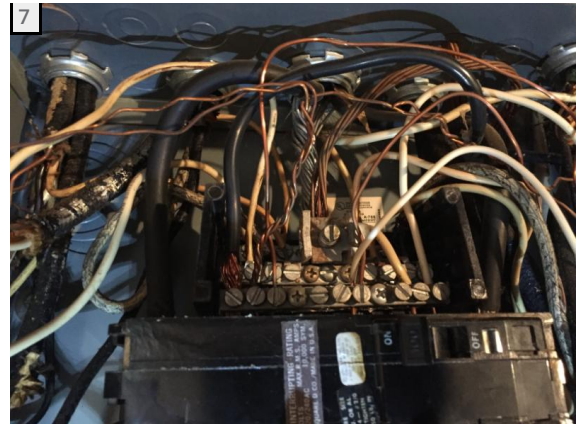
the outlets on the first floor tests with no grounding at all. There is no outdoor grounding rods of the electrical box and no grounding to the main water meter. Upon opening the breaker box, its questionable what someone was thinking when they wired it. Multiple grounds, some up to 3 are grounded on a single nob of a grounding rod with neutrals on the same ground. They all need to be on separate notches of the grounding rods. A licensed master electrician needs to review this, add anything that I am missing into the pot, undo and redo the inside of the box as its a mess. At this time, I think its about \$500-\$700 of electrical work but you are getting a quote from a licensed master electrician. Have this electrician put in a blank in that sub panel in the garage. There is a missing breaker and we do not want gunk to get into the sub panel. Also, technically, the garage is supposed to be GFCI outlets per the 2015 electrical code from the potential for snow and water to slush from a car pulling into the garage into the outlets and causing a fire.

**Needs review by master licensed electrician. House and box is grounded improperly.**

<b>Location</b>	Basement
-----------------	----------

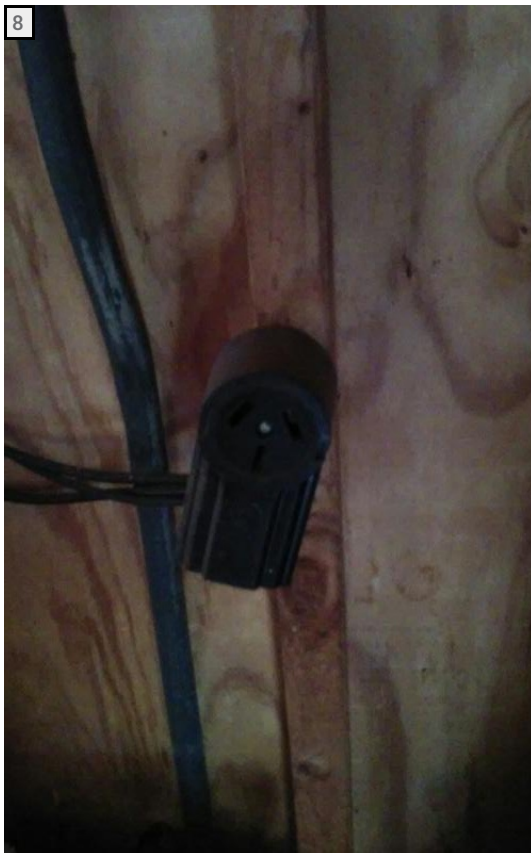
**Stove outlet should not be jumped off the sun panel**

**Location** Deattached Garage

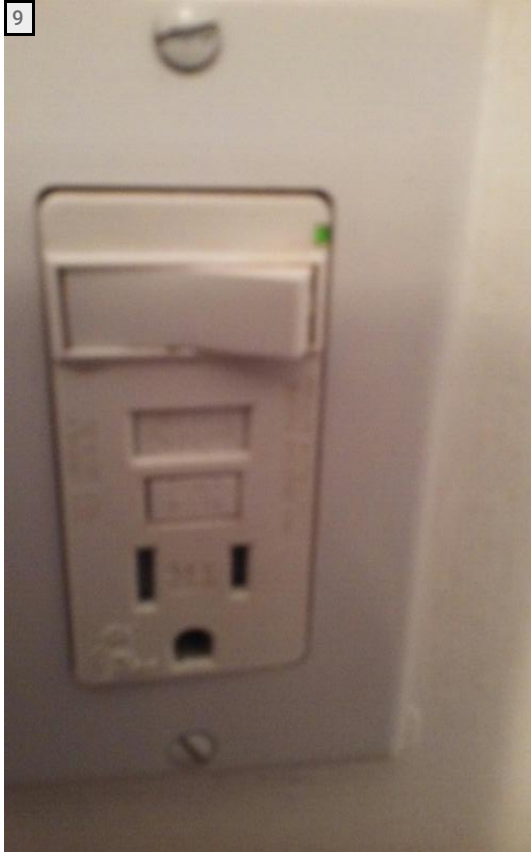
#### Incorrectly wired

Location Bathroom

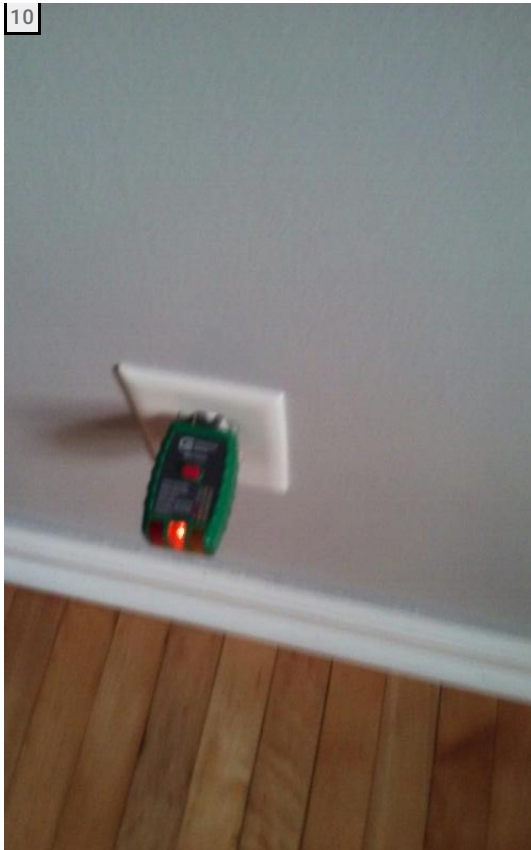
#### Not grounded

Location 1st Bedroom, 2nd Bedroom

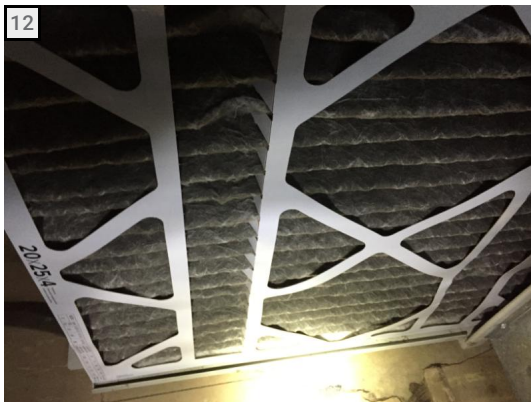
##### Filter is dirty

**Location** Basement

**Impact** A dirty filter causes the furnace to be less efficient

**Suggested Action** Change the filter

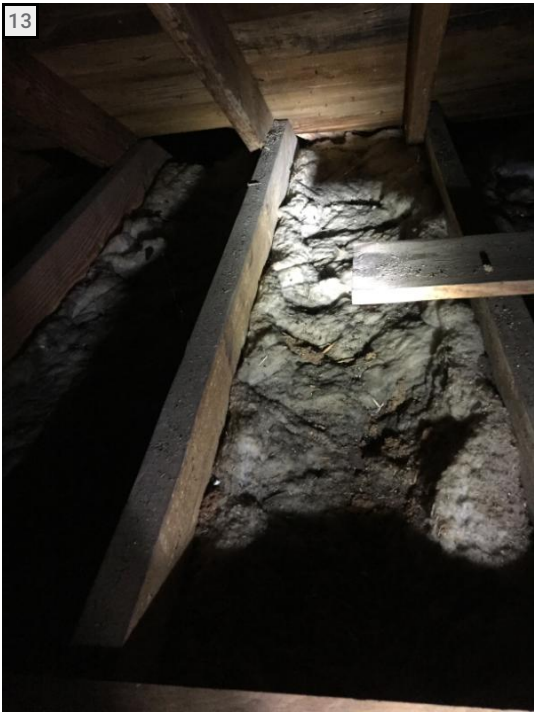
#### Level could be improved

Location	Attic, Basement
Impact	The heat loss and cost of energy is reduced by 1/2 every time the insulation thickness (R-value) is doubled
Suggested Action	Evaluate the cost of increasing the R-value levels in comparison to the energy savings

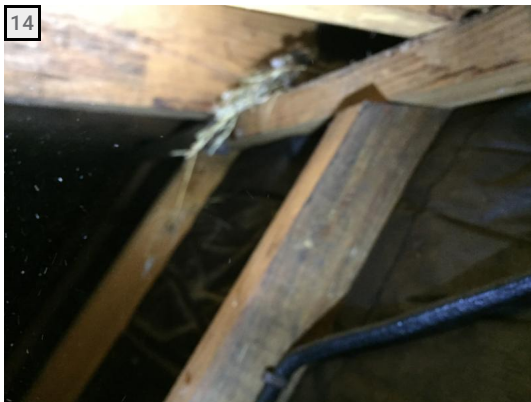
#### former birds nest

Location Attic

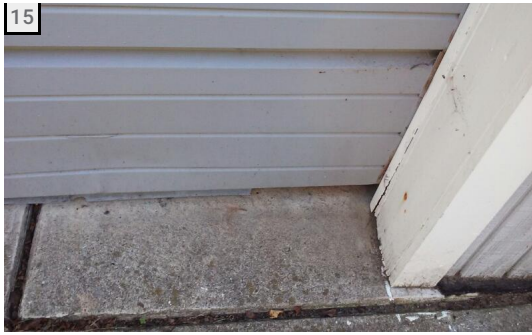
Impact Without proper protection, the door is not protected from the elements

Suggested Action Protect with weather-resistant seal, stain or paint

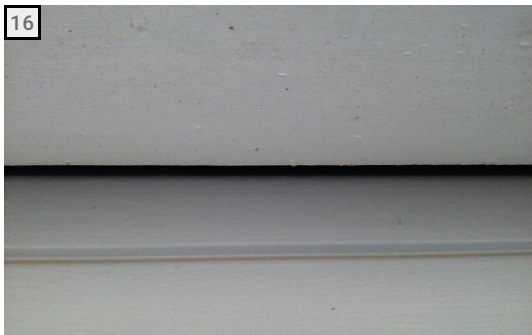
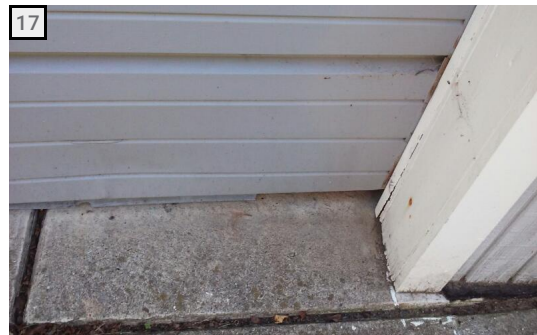
7) Your garage door is damaged. It is old. It has rust damage. It is not aligned properly. It is not sealed properly. This is not higher up on the list as you will survive with this old garage door. Replace it when you can.

#### Damaged

**Location** Deattached Garage  
**Suggested Action** Repair the damage or replace the door depending on your preference

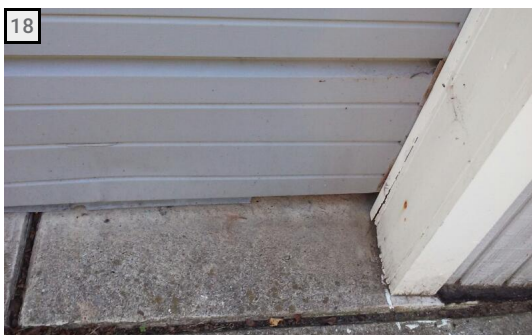
#### Weather seal incorrect

**Location** Deattached Garage

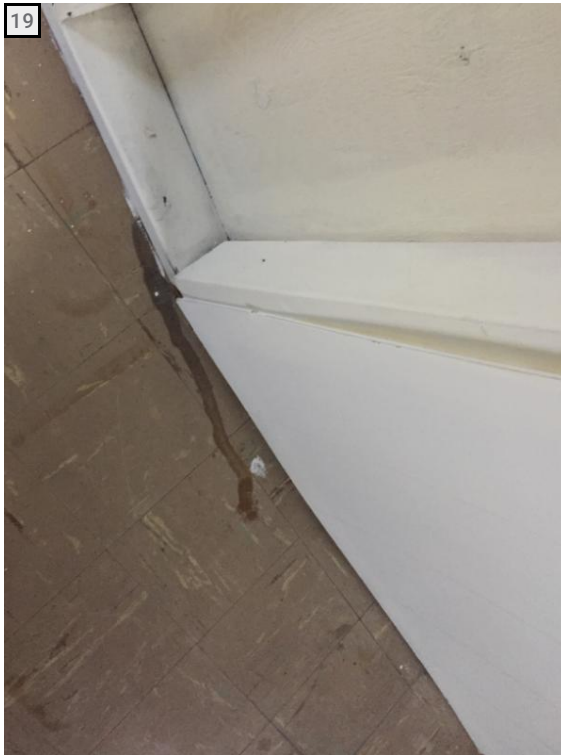
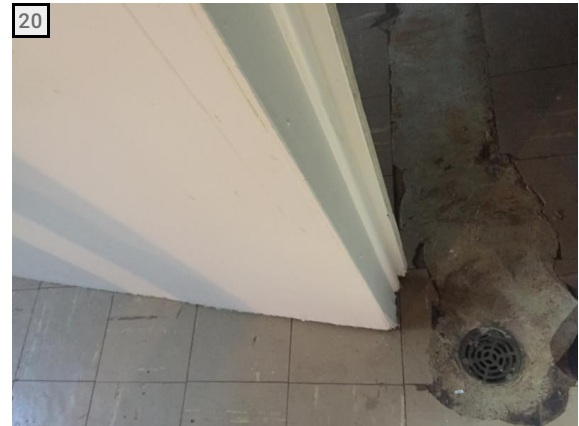
4) Basement flooding appears on the Sellers disclosures. We know it happens. I hypothesize that there are two sources of it. The first is when you walk down the stairs to the basement, there is an attempt to finish a wall where there is paneling with some water damage at the bottom of the paneling. What we have is people doing things that they were not supposed to do. Only licensed master professionals should be doing anything with penetrating a poured foundation wall or floor with a purpose. Otherwise, never hammer, screw or nail anything in a poured foundation as you ruin the water proof seal the concrete provides. The 2X4's nailed into the floor at the bottom of the stairs did just that. Water can come in around the nails. A modification/ repair needs to be done in a manner that does not allow water to come into the holes where the nails are. The paneling needs to come down. It has water damage anyways. It may (MAY) be possible to use an epoxy or caulking type sealant around the nails to stop it. This is a MAY. I am not sure. So when Epoxy company comes out for an epoxy floor over the likely asbestos tiles, ask them. They will know how to seal that somehow with epoxy and make it look good.

As disclosed on Sellers disclosures, there is some amount of basement flooding. There is evidence of water damage on paneling on an attempt to install a wall in the basement by nailing 2 X 4's into the floor. Additionally, water likely is coming up from the french drain in the basement floor from heavy rain and a stan pipe is recommended.

Location Basement

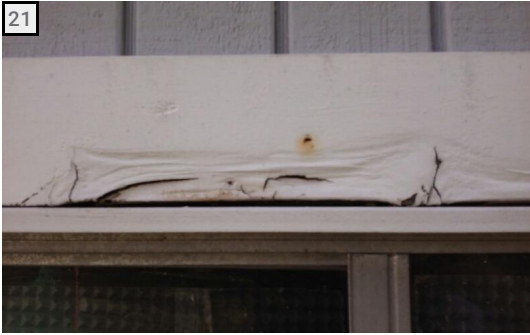
### Damaged trim

Location Deattached Garage

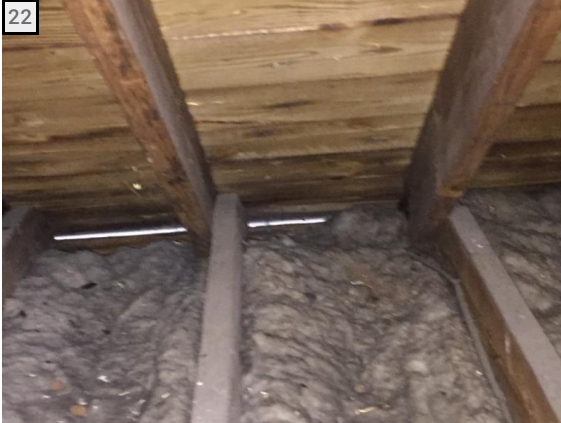
There is a small/ minor gap where the gutters on the outside meets the attic. Water will not get in but bees and bugs can. It may be possible to spray foam or caulk this from the outside or the inside, carefully. If not, a portion of the gutter can be deattached and a small sheet of aluminum added as fascia behind the gutters to repair this.

**Small gap between where gutter meets fascia board, meets the attic.**

**Location** Attic
